DEPARTMENT OF TRANSPORTATION

Quality Assurance and Source Inspection

Contract #: 04-0120F4Cty: SF/Ala Rte: 80 PM: 13.2/13.9File #: 69.28**WELDING INSPECTION REPORT****Resident Engineer:**Siegenthaler, Peter**Address:** 333 Burma Road**City:** Oakland, CA 94607**Report No:** WIR-025851**Date Inspected:** 28-Jun-2011**Project Name:** SAS Superstructure**OSM Arrival Time:** 1900**Prime Contractor:** American Bridge/Fluor Enterprises, a JV**OSM Departure Time:** 700**Contractor:** Zhenhua Port Machinery Company, Ltd (ZPMC), Changxing Island **Location:** Shanghai, China

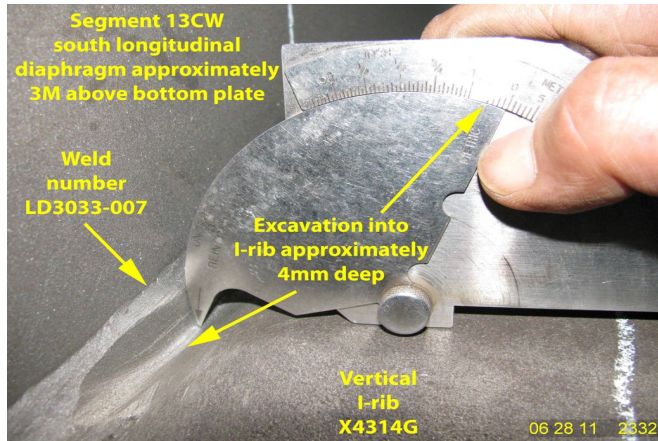
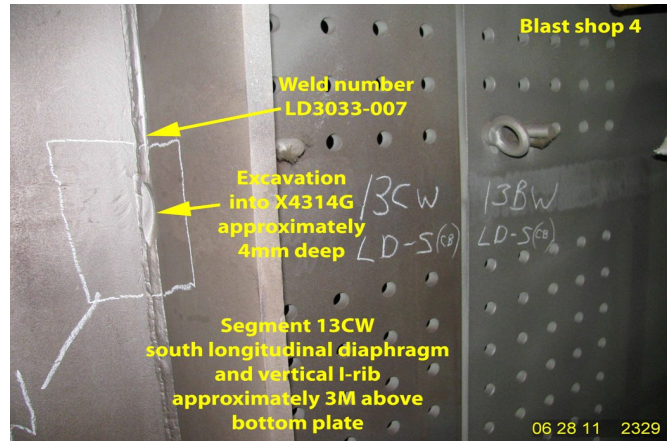
This QA Inspector and QA Inspectors Dennis Combs, Robert DeArmond, Paul Dawson responding to phone notification from ABF Inspectors performed a pre-final sandblast inspection of Segments 13BW/13CW, middle portion between longitudinal diaphragms, from panel point 120 to the transverse joint to Segment 14W at approximately panel point 124.7, from 1 meter below the deck plates down to and including, the bottom plate. This QA Inspector observed several surface irregularities requiring grinding. These areas were marked for grinding. This QA Inspector observed several surface irregularities appearing to be arc strikes requiring grinding and magnetic particle testing (MT). These areas were marked for grinding and MT. This QA Inspector also observed a 4mm deep excavation in the weld designated as LD3033-007 requiring weld repair. See photos below. The weld repair was documented and reported in QA Inspector Robert DeArmond's Post Blast Repair Report of this date. See that report for further details.
